Bloodhound MKII Restoration News and Progress

June to October 2015

The BMPG own a Bloodhound MKII Launch Control Post (LCP) and radar Type 86 (T86), both are currently under restoration.

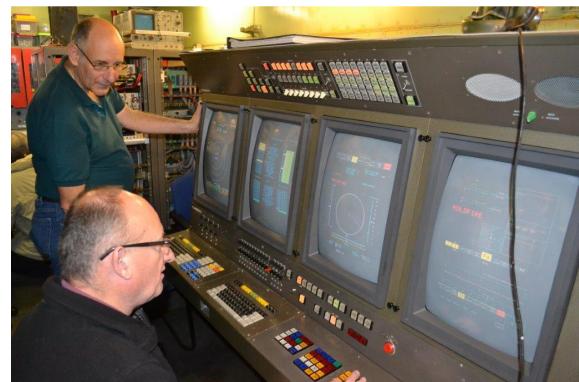
Bloodhound MKII simulator
Demonstrated by Neil Cartman

Following three years of restoration the simulator, consisting of the computer racks and the display console, are operating normally. One of the main challenges in achieving this state was the replacement the original 'shoe box' disk system with a SCSI interface to the Argus 700 and then moving from rotating disk technology to solid state. The LCP/simulator software now runs from a CF card!

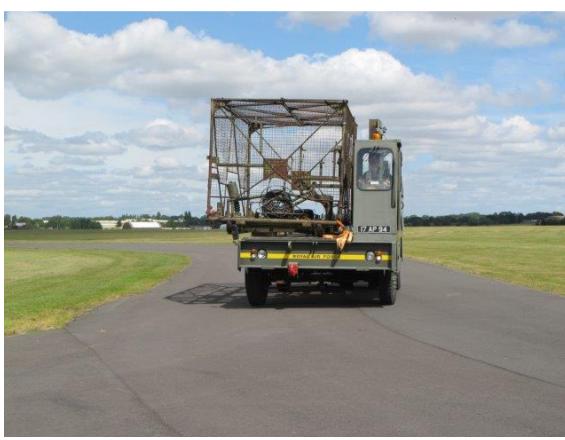
The 'cage' arrives following unloading from its road transport

In August the BMPG acquired a Type 86 aerial cage. So why were we keen, and fortunate, to get an aerial cage for the radar? When the radar moves from its current location the only way of safely transporting the aerial assembly is with the cage that was specifically designed for that purpose as the aerials cannot be described as a regular shape. Any alternative to the original cage would have involved some complex fabricating, plus a lot of time and money.

The RAF Museum kindly loaned us the use of a Bloodhound sideloader and the staff to deliver the aerial cage to the hangar where BMPG's Launch Control Post and Type 86 radar are kept.

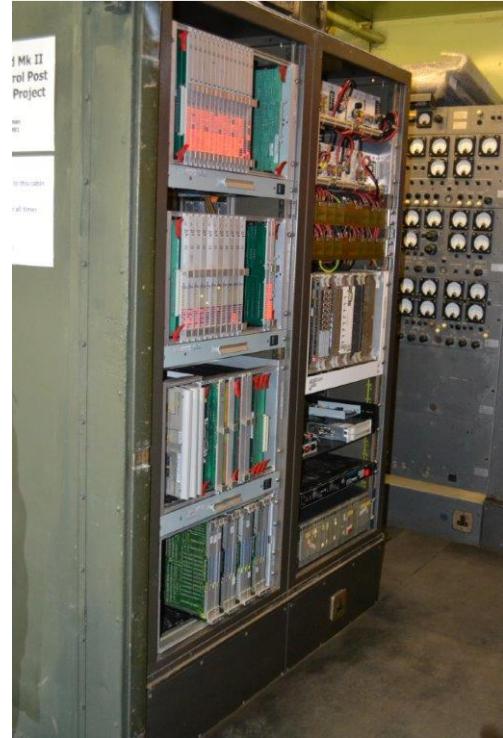
Computer Racks in the MK2A LCP

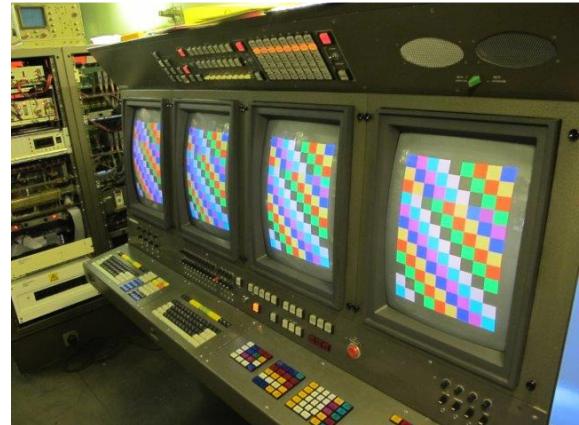
Display Console –CHARGE Testing
A display that is not used operationally!

The four LCP/simulator's display VDU's are driven by Ferranti's CHARGE (Compact High-Resolution Advanced Raster Graphics Equipment) system. For the past year the display system has exhibited a few 'wobbles' from time to time usually in the form of software errors or the display sync being lost on one or more of the VDU's. After much head scratching and testing the problem was discovered to be the mains supply to the hangar in which the LCP is kept. Running the LCP and hence the Bloodhound simulator on a diesel generator, now for a second time in two months, has confirmed the display problems are due to a poor quality mains supply. The Bloodhound simulator ran faultlessly when powered by a generator for the recent BMPG Open Day, with no display or any other problems being experienced. The display system is tested from time to time and can be reset by running Ferranti's in built CHARGE test program, initiated from the FT81 system monitor.

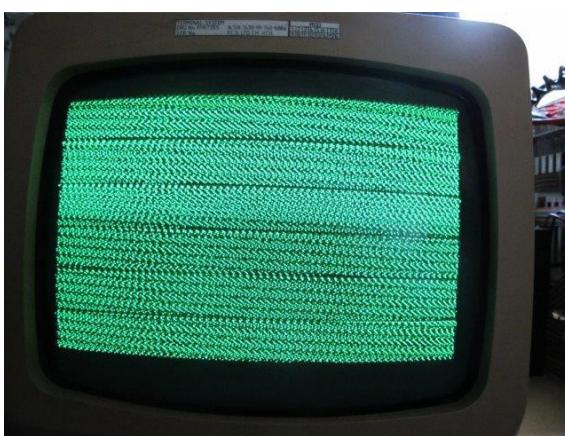
FT81 - Faulty Display
Not exactly readable!

Recently the system monitor failed, not a 'stopper' for running the Bloodhound simulator as the Ferranti FT81 system monitor can be replaced by a laptop (Windows 7 in this case) running a VT100 emulation with a USB to serial adapter. A set up that is not designed as a full emulation of the FT81 but one that works, at least it runs the simulator.

The system monitor is now serviceable again following several hours of fault finding which resulted in the replacement of a faulty 74 series TTL device on the monitor's video card. The video card is based on the Z80 microprocessor design. Ferranti used the Z80 almost exclusively for the Argus 700 Input/Output (I/O) cards and the FT81 video card, anywhere that some processing was required. Being able to fault find Z80 microprocessor systems is a must.

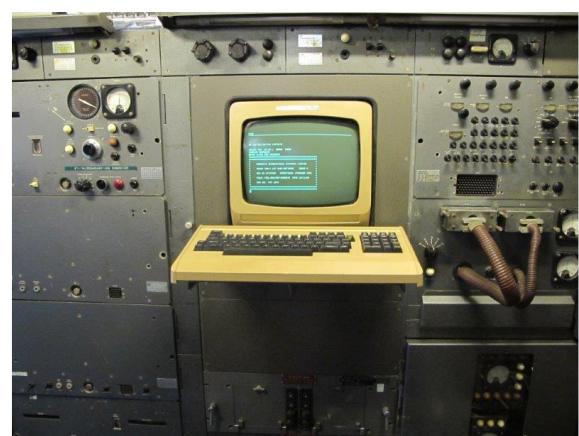
FT81 - Correct Display
Refitted to L Rack in the LCP

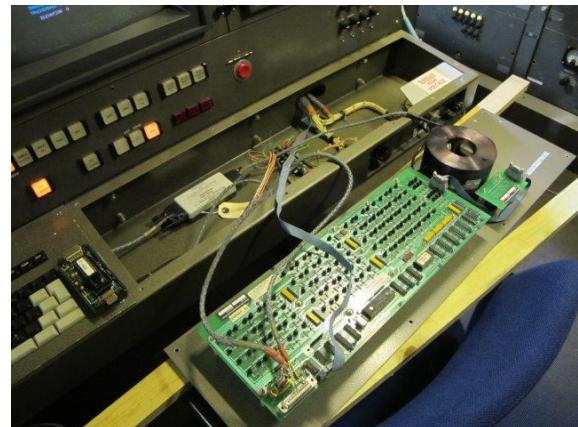
A recent but minor fault with the Bloodhound simulator was the Engagement Controller's tracker ball. The tracker ball would initially move the display marker in the horizontal plane and then stopped moving altogether. The fault was eventually traced to a poor connection in the 8 Port Serial Line Drive unit in the Argus 700's I/O rack. The +5V supply to the tracker ball encoder dropping to +3.5V, not enough to drive the TTL used by the encoder. The poor connection was down to oxidation on a spade terminal in the line drive card. It is not surprising that oxidation causes problems, before being acquired by the BMPG the LCP was exposed damp, even wet, conditions for twenty two years.

Trackerball and E.C.'s keyboard
Removed and inverted for fault finding

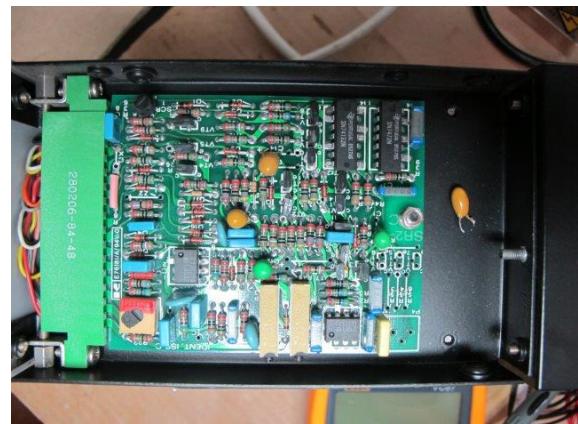
The faulty power supply was a Farnell G15-16S giving 0V output instead of the rated +15V DC. Experience has shown that any fault (so far) on a Farnell G series power supply shuts down the output.

For the technically minded the fault was eventually diagnosed to a faulty '2-Input NAND Gate with Schmitt Trigger Input' (SN74132N) TTL device on the power supply's control card. Power supply now repaired was refitted to the computer rack.

Power Supply G15-16S – Control Card
Bead tantalum capacitors also changed as a matter of course when a fault develops on the control card

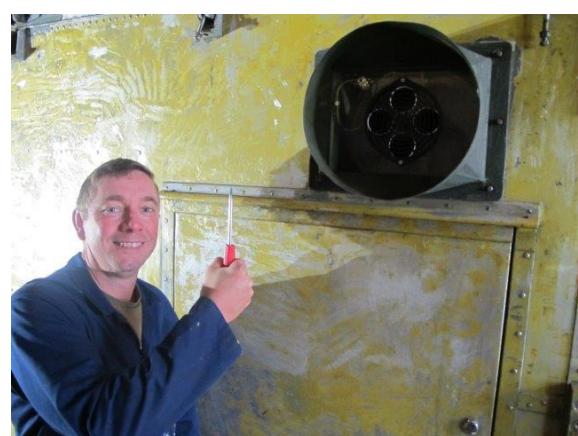
When running the Bloodhound simulator for a period of time with the LCP doors are closed, it gets warm! In operational use the LCP was attached to a large 'No 54 Mk2' air conditioning unit. Such a large A/C unit is not a practical option for running the LCP with its simulator in preservation. The solution is to fit a thermostatically controlled exhaust fan in the existing air conditioning extractor vent. The thermostat used to control the fan is the original as used by the No 54 Mk2.

New LCP Extractor Fan
I made it (the fitting not the fan) – Pete Murray

Pete Murray used his engineering skills to fabricate a fitting to mount the extractor fan.

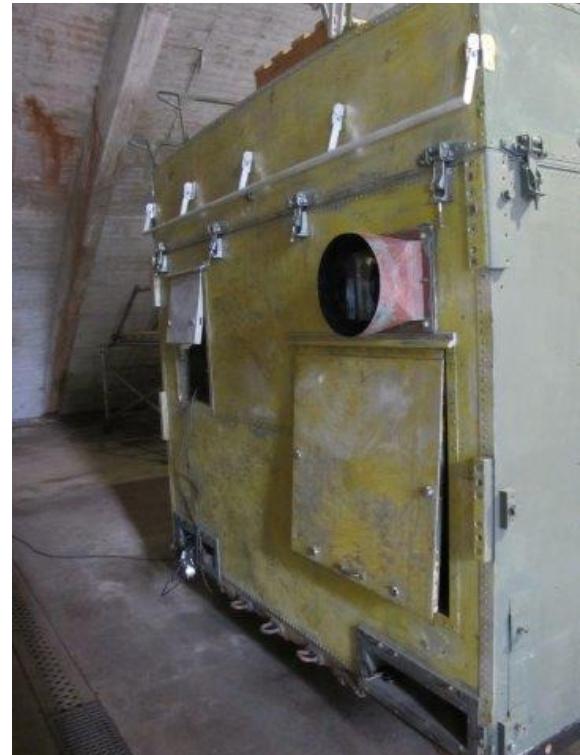
A compromise here as some broken items will be replaced, where possible. Typical of this approach is the replacement of the chromed fittings that cover the locking key access holes in the various cable hatches. Many have been snapped over the years but the BMPG have been fortunate in acquiring identical covers so as many of the chrome fittings as possible will now be replaced.

End wall of LCP cabin

Showing some of the chrome locking key covers

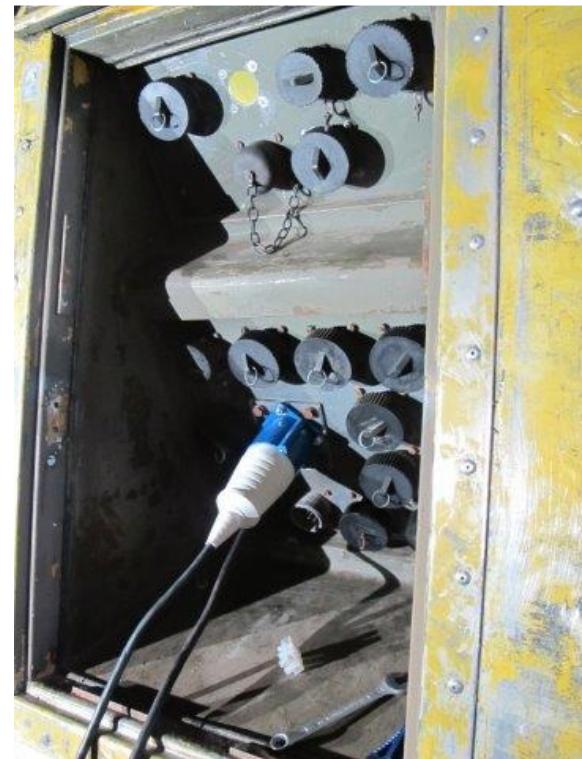
The BMPG do not have any of the original cables for the LCP so the existing three phase mains input socket on the LCP's cabin wall is very much a socket without a plug. There is also a change to the mains required for the LCP as only a single phase is used. The computer racks and display system in the LCP only one of the three phases supplied so one of the first tasks was to change any supply running on a different phase to the one common phase, namely the cabin lights supply. All the restored equipment in the LCP now runs off a single phase so there is no requirement for a three phase plug and socket so it has been replaced with standard 32 Amp single phase plug and socket.

Industry standard 32 Amp plug and socket

The second cable in the previous photo is the earth strapping to an earth spike in the ground outside the hangar.

Once again Pete Murray machining skills were needed to manufacture an adapter to fit the 32 Amp socket to the LCP.

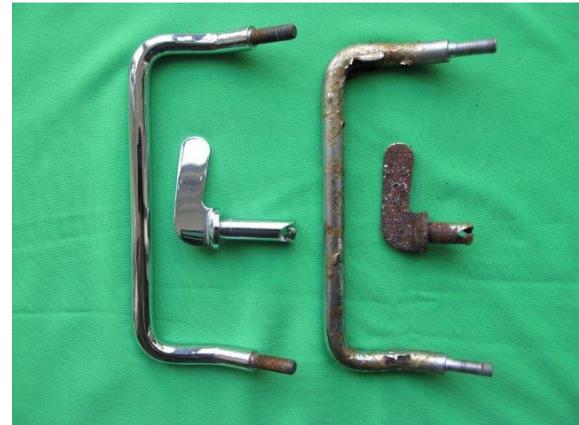
Leave chromed metal handles and latches in damp and wet conditions for twenty odd years and the result is shown in the adjacent photo. Chrome has corroded and peeled away from the base metal. To leave the equipment drawers and covers with handles and catches in this condition would certainly detract from the internal appearance of the LCP. Action was needed.

The company carrying out the re chroming advised us that the original process used for chroming contributed to the terrible state of the chrome fittings when the BMPG took ownership of the LCP. When re chroming all items were treated to an acid bath, polished, coated with copper through electrolysis and finally chromed. When the LCP was originally built the metal handles did not receive a copper coating resulting in the severe deterioration of the chrome over time.

Comparing the refurbished and original chrome handles
Before and after

Over 300 chrome 'D' handles, spacers and latches were removed over two days, all were badly corroded. Once removed the handles and latches were sent for re chroming and have now been returned and work has already started on re fitting.

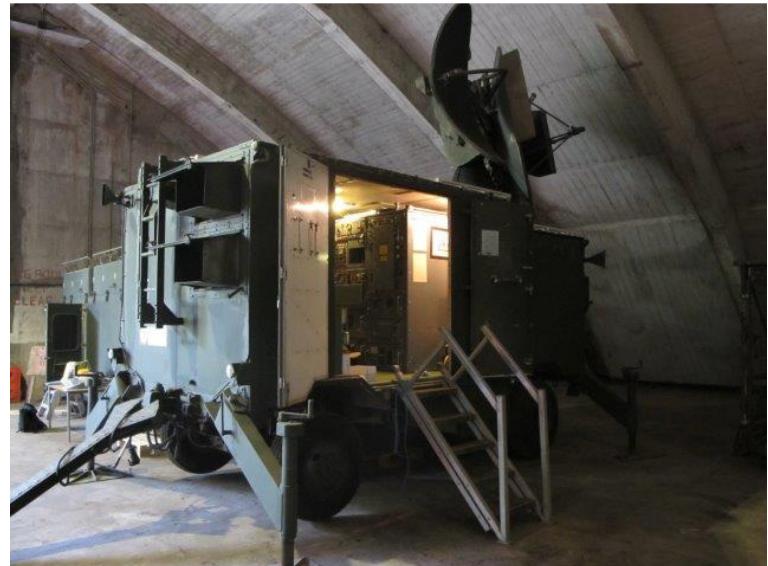
BMPG's Radar Type 86, ex 85 Sqn C Flt, Yellow Section
Lights 'On'

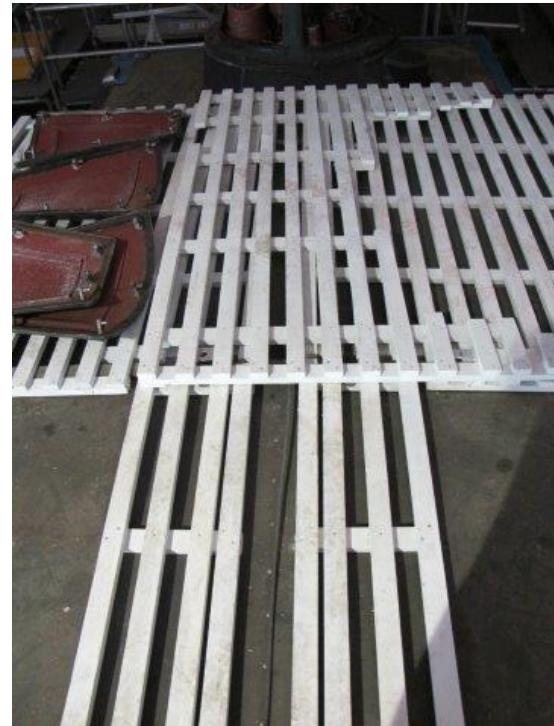
Now complete and looking good with a coat of white primer. The original rood decking was completely rotten and unsafe to walk on.

Type 86 cabin roof with decking being replaced

Again, the progress on remanufacturing the roof decking is carried in previous reports but the task is now complete. A lot of the work, and painting, was carried out by Ian Gibbon who made such a good job of it that anything to do with wood is immediately allocated to him. The wooden rubbing strakes along the top edge of the cabin walls also need replacing. Not an immediate task, just needs to be done at some time - Ian.

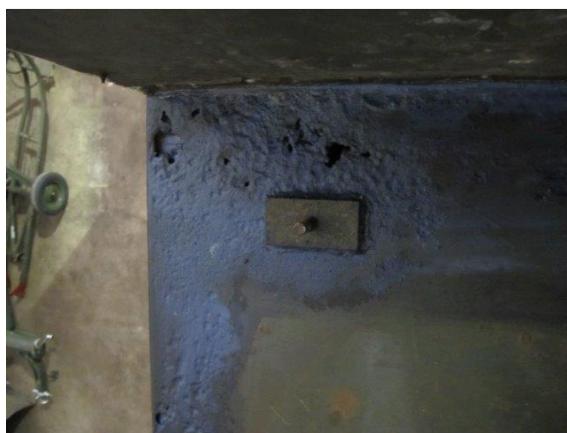
The most important restoration task for the BMPG is to treat the corrosion on the cabin roof section around the aerial pedestal. The radar cabin is constructed from aluminium sheet, except for the roof under the pedestal which is mild steel. Unfortunately the condition of this roof section only became apparent once the roof decking was removed.

The degree of corrosion is shown in the photographs below. Fortunately, it is the thin mild steel sheet that has corroded through and all load bearing points are still sound. Treating the corroded areas will eventually involve the cutting out and welding in new plate. For now the corroded plate has been treated with an anti-corrosion solution.

Corrosion in the mild steel sheet – pedestal roof section

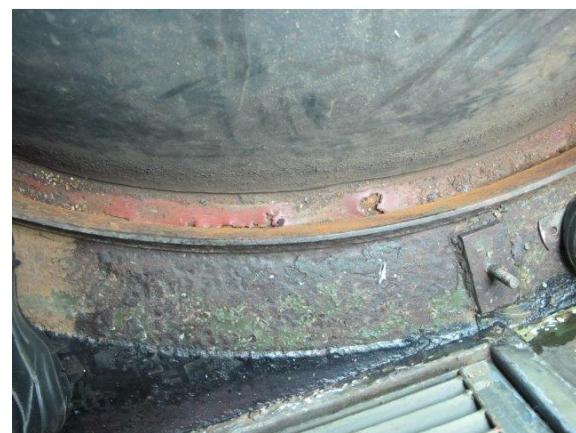
Corrosion around the pedestal ring

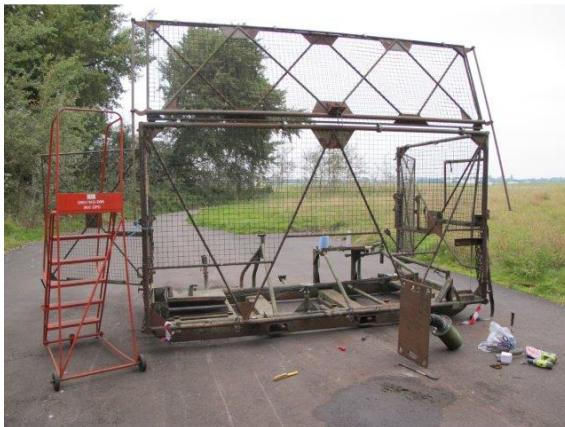
Work continues on the T86 Ae cage

At some time the Type 86 radar and LCP will need to be moved from their current location. When this happens the biggest challenge will be removing and transporting the Type 86 aerial assembly. It was with tremendous relief that the BMPG recently acquired an aerial cage for the Type 86 aerials. Prior to acquiring the cage it was a case of, how can we build a frame to support the aerials for transit. Not an insignificant task but that problem is now solved.

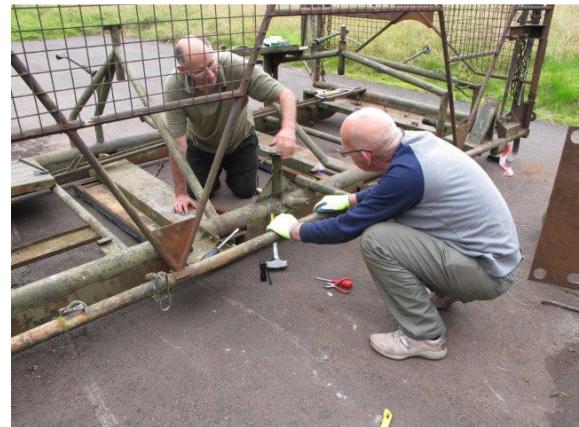
Neil Cartman and Dave Scobie
Note the BIG hammer!

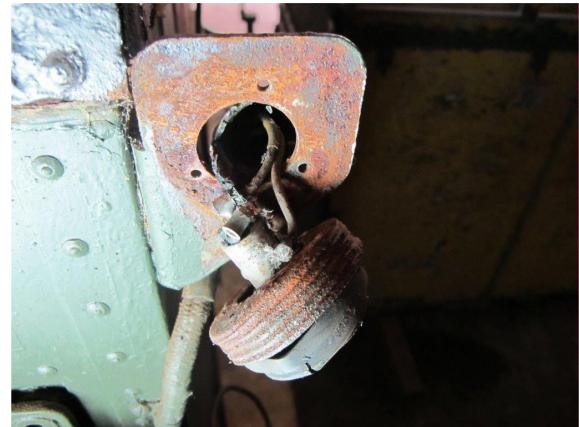
A task that lies ahead is the replacement of the radar cabin's four running lights, one fixed to each corner of the radar cabin. These lights were not a top priority even when the radar was operational, a photo of BMPG's Type 86 while at Bawdsey clearly shows at least one running light was broken when in service. The twenty plus years the radar was left in the open after being retired from RAF service, the running lights end up like the one shown; damaged, no lens glass left and rusty.

Radar Type 86 running light
Unbolted from its mounting bracket

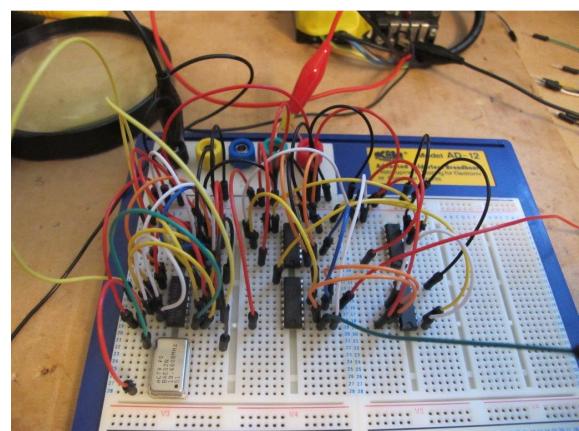
PeriBus is a 'sort of' serial bus that connects the Argus 700 to all its I/O PCBs and there are a lot of them. The reason for attempting a PeriBus emulator is to see if the various I/O cards can be communicated with and hence initialised without the Argus 700. Once I/O control is achieved over the PeriBus then the addressing, processing and replies from any I/O card can be tested.

Prototyping the timing logic to drive the Serial PeriBus
